AFFDL-TR-77-87

DEMONSTRATION OF ACOUSTIC EMISSION SYSTEM FOR DAMAGE MONITORING OF FULL SCALE METALLIC AIRCRAFT STRUCTURES DURING FATIGUE TESTING

GRUMMAN AEROSPACE CORPORATION

SEPTEMBER 1977

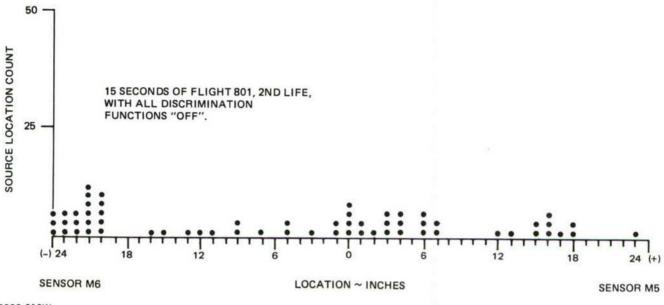
Fig. 10 FS 992 Outboard Bulkhead

The six areas were monitored utilizing the extraneous noise discrimination techniques of Spatial (including master-slave and coincidence) and Wave Form discrimination. Figure 10 shows a histogram display of false signal source locations generated by extraneous noise with the discrimination functions turned off for 15 seconds during flight #801 on the FS 992 outboard bulkhead. If the discrimination functions were left off for the duration of the entire flight (approximately 25 minutes) there would be about 6500 false signal source locations generated, making it impossible to detect AE event signals. It was observed that approximately 50% of the false signal source locations, caused by extraneous noise signals, were eliminated with "Wave Form" discrimination. The test could not have been monitored without all of the discrimination functions in operation. With the discrimination functions on, approximately 98% of the extraneous noise signals were eliminated.

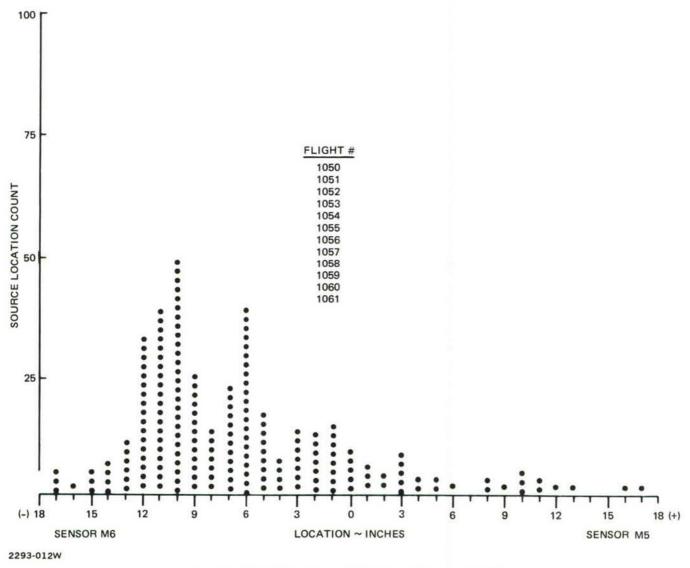
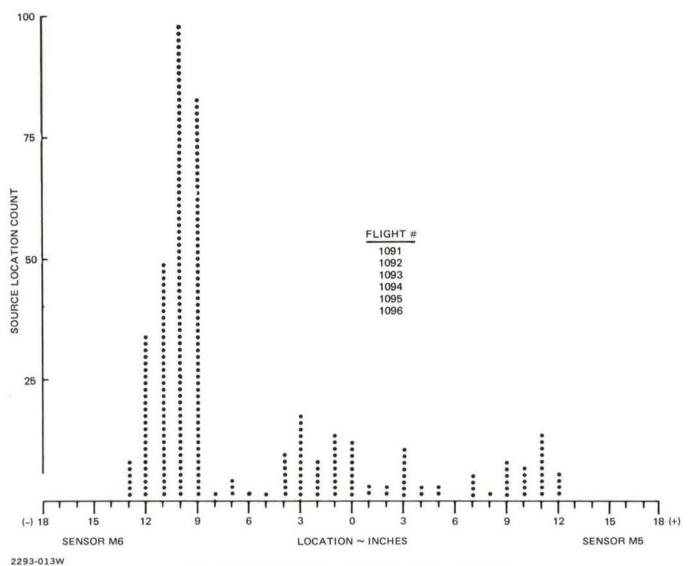
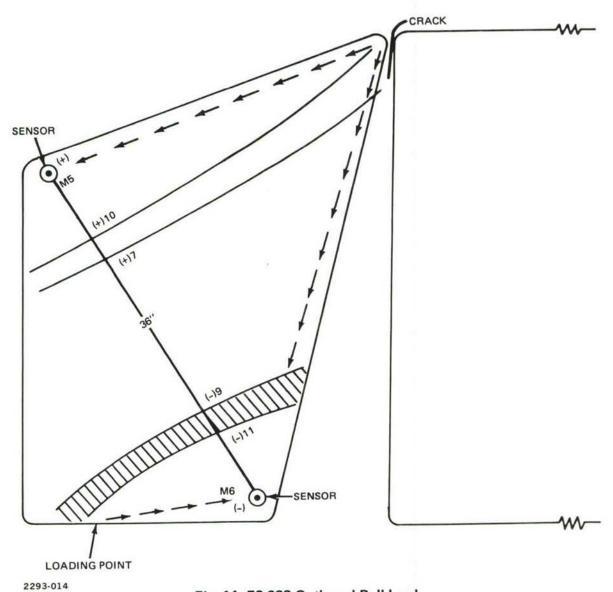
The AE events generated at signal source locations (-)9 and (-)11 continued through flight 1280, the end of the second fatigue life. The shaded area shown in Fig. 14 between hyperbolas (-) 9 and (-) 11 indicates the area of concern on the FS 992 outboard bulkhead. However, after completion of the second fatigue life, an inspection revealed an 8 to 10-inch crack at the location between hyperbolas (+) 7 and +(10) of Fig. 14. The acoustic emission system detected the crack propagation in the 992 outboard bulkhead (Fig. 12 and 13), but the location was inverted 180° because of an incorrect polarity sign (negative half of sensor axis instead of positive).

An investigation was conducted to determine the cause of the 180° error in the crack location on the FS 992 outboard bulkhead. It is believed that cyclic extraneous noise interference introduced at the loading point below sensor M6 (Fig. 14) interacted with the acoustic emission event signals and caused the error in the following manner. Without interference, the crack would be located as follows (Fig. 14): sensors M5 would be actuated first by the AE event signal which would register a (+) polarity; at Δ T time later, sensor M6 would be actuated to determine the signal source location on the positive half of the axis between the sensors. This location is shown in the hyperbolic area between (+)7 and (+)10.

Without placing a slave sensor at the loading point, repetitious, unrejected extraneous noise was introduced into the area. Sensor M6 was actuated first, registering a (-) polarity. At ΔT time later, an AE event signal from the cracked area received at sensor M5 would determine a signal source location on the negative half of the axis between the sensors. Based on the location of the loading point, multiple erroneous signal source locations would be located in the shaded area between hyperbolas (-)9 and (-)11, as indicated by fatigue test data results.

The erroneous crack location experienced demonstrates the complexity of detecting acoustic emission signals during fatigue cycling because of extraneous noise interference. It was possible to detect acoustic emission activity on the FS 992 outboard bulkhead despite unrejected extraneous noise interference, only because of the cyclic nature of the noise interference. If the extraneous noise had been random in nature, it would not have been possible to detect any acoustic emission activity on the bulkhead without rejection of the extraneous noise interference by the system hardware. Unrejected random extraneous noises would interfere with AE event signals, generating a multitude of random erroneous signal source locations, and masking AE event signals, as explained in System Operation, Section II.

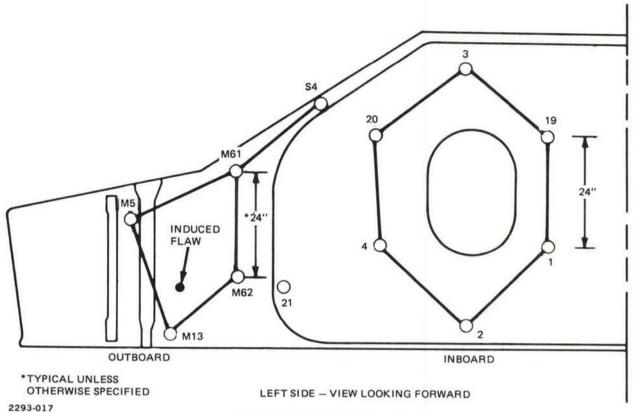
Fig. 17 FS 992 Bulkhead

The induced flaw on the FS 992 outboard bulkhead shown in Fig. 17 also showed no signs of acoustic emission activity during the third fatigue life. Inspection at the end of three lives revealed that there was a slight growth of 0.060 inch between flights 784 and 1280. This extremely small growth rate (0.060 inch during 496 flights) demonstrated that the amount of acoustic emission activity generated by an extremely slow-growing crack was not enough to be detected because of the large amount of extraneous noise signals.

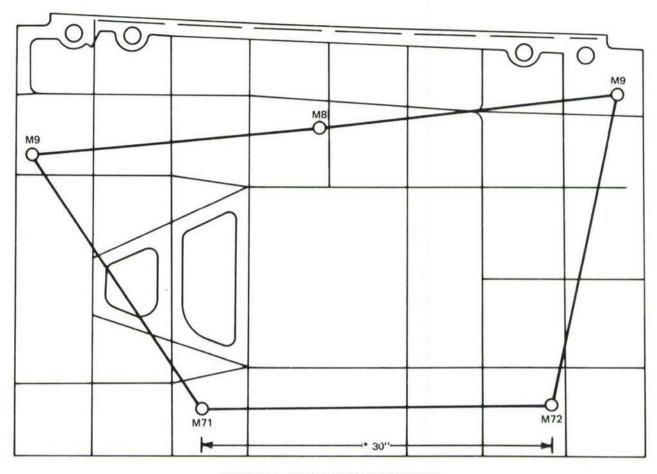
Fig. 19 XF84 Outboard Intermediate Rib

There was no significant acoustic emission activity on the XF84 Outboard Intermediate Rib or the FS 992 inboard bulkhead during monitoring of the third fatigue life (1280 flights). Inspection at the end of three lifetimes showed that cracking had not occurred on either the XF84 Outboard Intermediate Rib or the 992 inboard bulkheads. These bulkheads had not been previously flawed.

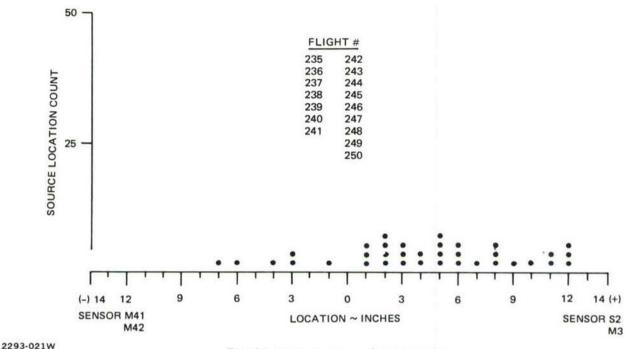
Fig. 21 Bottom Cover (Third Life)

The induced flaw on the bottom cover shown in Fig. 15 did show acoustic emission activity during the third fatigue life. Figure 21 shows no significant activity generated on the bottom cover during flights 235 through 250. This graph shows virtually no signal source locations generated for approximately 8 hours of on-line monitoring time. However, Fig. 22 shows a marked increase in AE activity during flights 251 through 264. Signal source locations (based on sensor pair S2 and M41) began to register at a location between hyperbolas (+)3 and (+)6 as shown in Fig. 23. Sensors M3 and M42 were monitored for a short period of

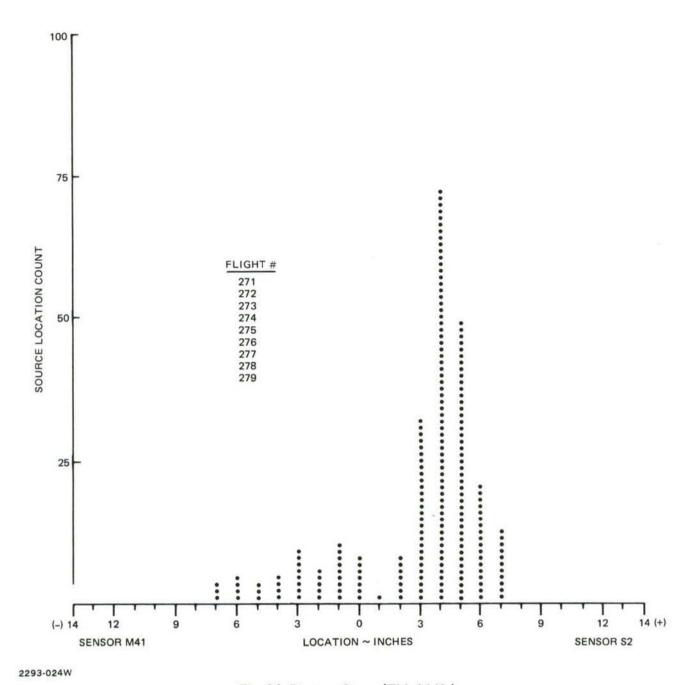
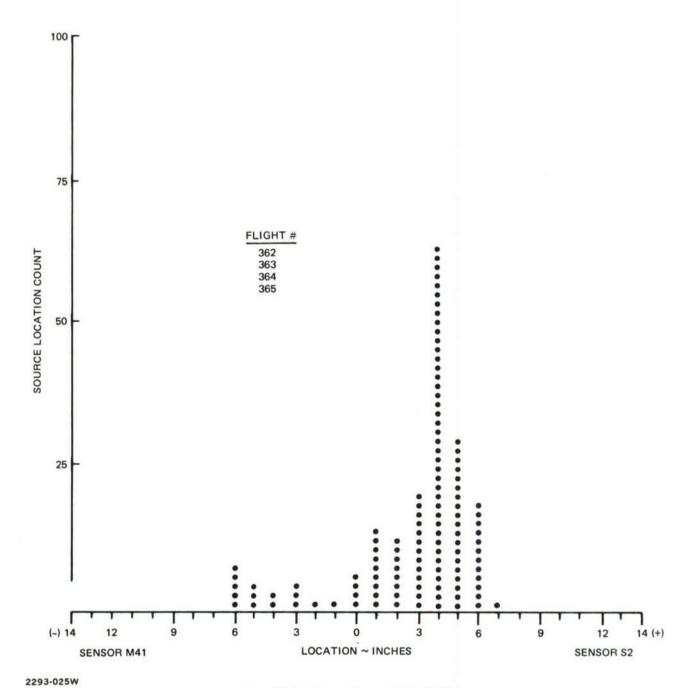
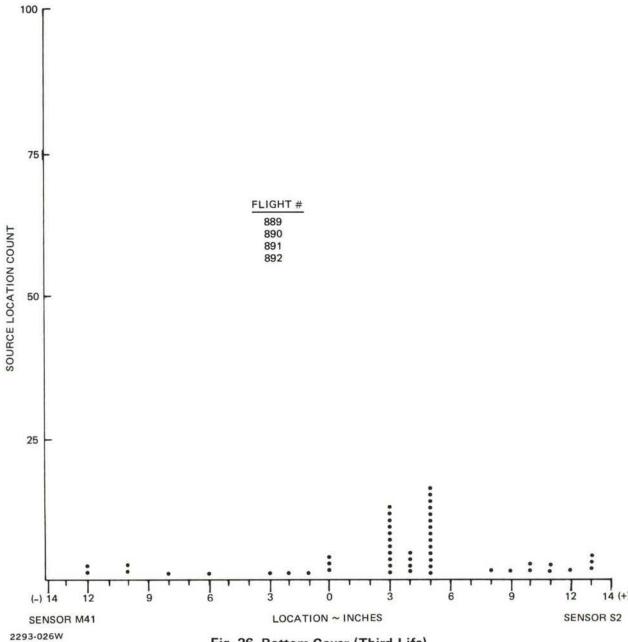
Fig. 24 Bottom Cover (Third Life)

time to verify the induced flaw site. The induced flaw on the bottom cover showed AE crack initiation at that point in the third life test (flights 251-264). Figure 24 shows the same signal source locations generated from the induced flaw location during flights 271 through 279 (approximately 4 hours on-line monitoring time using sensors S2 and M41). Quality Control Inspection revealed an initial crack growth of 0.061 in. from 0.140 in. to 0.201 in. at flight 339. This was the first sign of flaw growth by conventional NDT methods. Signal source locations from the induced flaw were detected approximately 80 flights before detection by conventional NDT methods.

Figure 25 shows an increase in the amount of signal source locations at the induced flaw location. Approximately the same number of signal source locations were detected in two

Figure 26 shows a marked decrease in the number of signal source locations generated from the flaw location during flights 889 to 892. This denotes a general decrease in the crack growth rate.

Quality Control Inspection at the end of the third life revealed a crack growth on the bottom cover of 0.440 in. from 0.140 in. to 0.580 in.

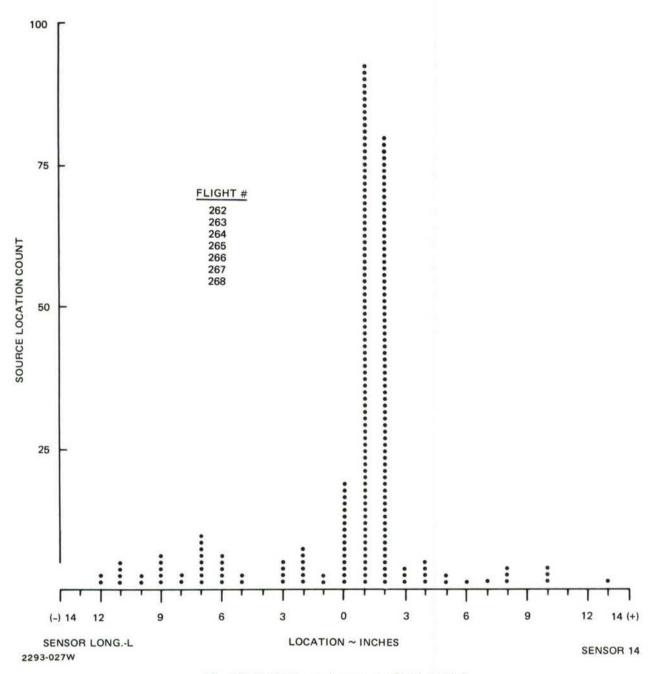
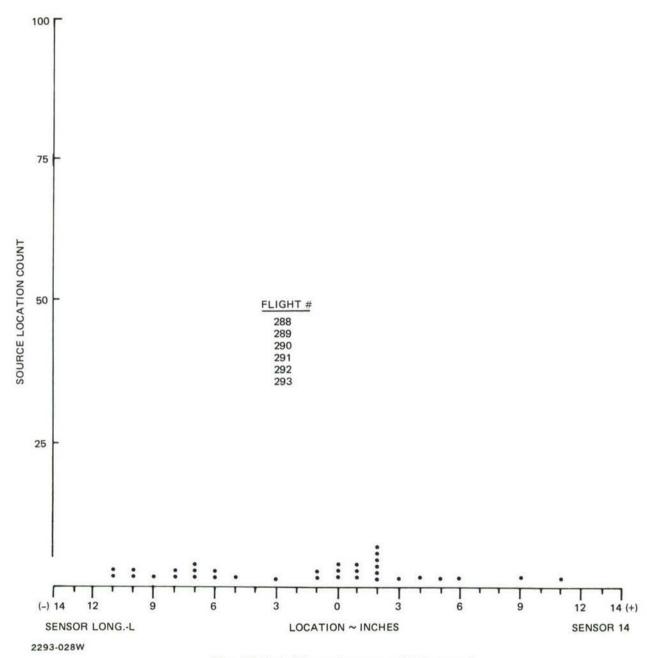
Fig. 27 Left Upper Longeron (Third Life)

The left upper longeron began to generate multiple signals during flights 262 through 268. Figure 27 shows a histogram of the buildup of these signal source locations between locating sensors 14 and Long. -L during those seven flights.

An inspection several flights later revealed three loose bolts in the area as shown in Fig. 27 between sensors 14 and Long.-L. After the bolts were tightened, the signal source locations at (+)1 to (+)2 inches (Fig. 27) were eliminated. Figure 28 shows the disappearance of these signals from flights 288 through 293. The left upper longeron monitoring indicated no other acoustic emission activity for the remainder of the third life. No cracks were found in the longeron when inspected at the end of three lifetimes.

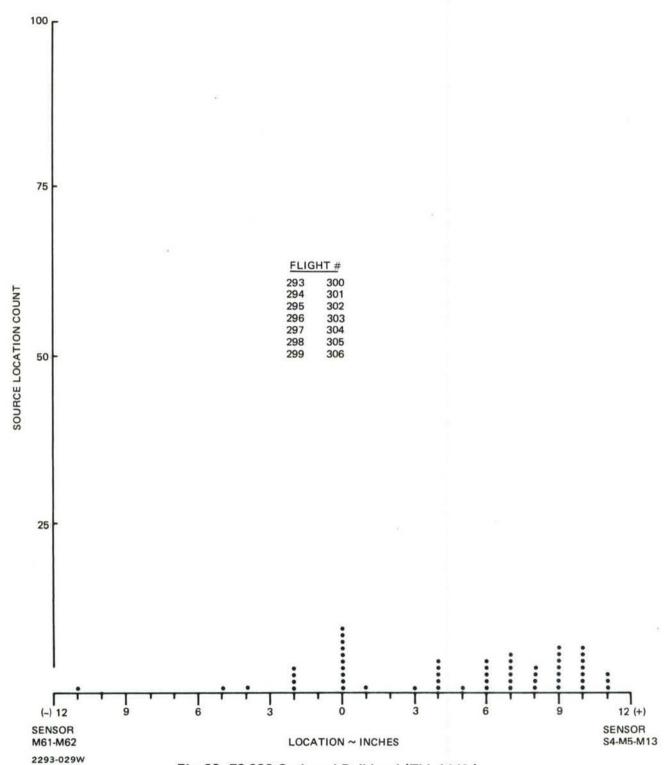
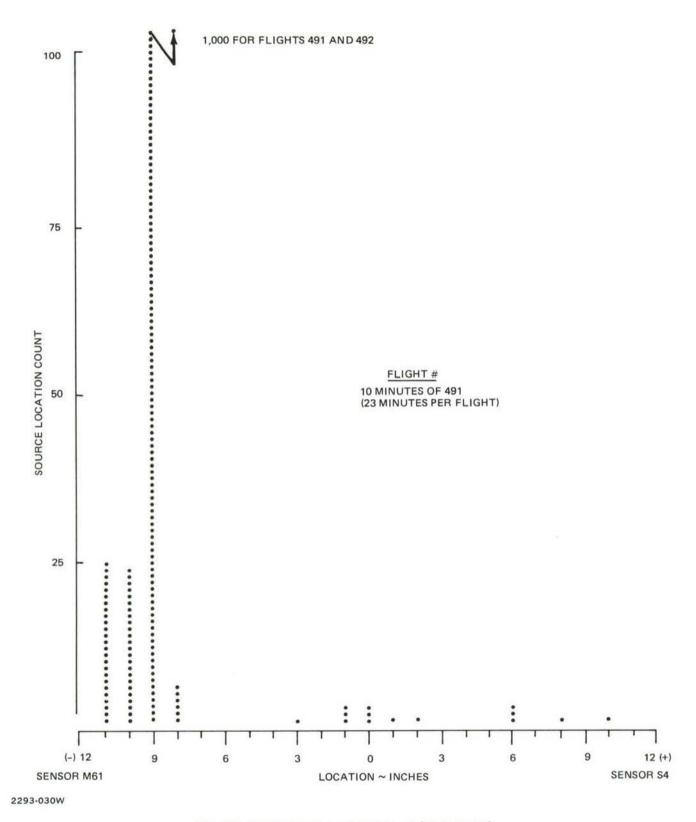
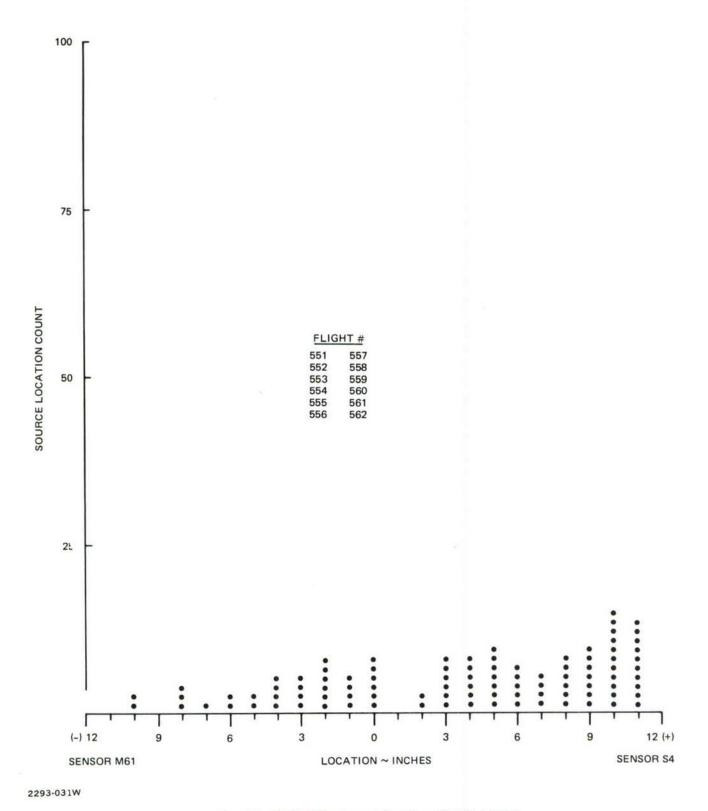
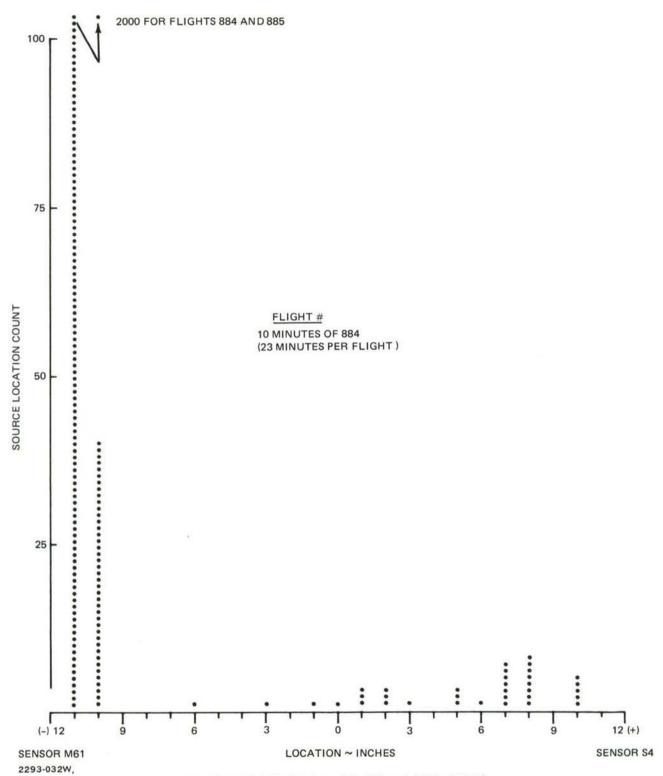
Fig. 29 FS 992 Outboard Bulkhead (Third Life)

The FS 992 outboard bulkhead showed no signs of acoustic activity until flight 489. Virtually no AE activity is shown in Fig. 29 for flights 293 through 306 (approximately 7 hours of monitoring time). Multiple signal source locations were detected during flight 491, as shown in Fig. 30.

Figure 30 shows the AE activity for 10 minutes of flight 491. The total number of signal source locations for flights 491 and 492 exceeds 1,000. Several visual inspections of the area revealed no cracking or damage.

Inspection after the third life revealed no cracking or damage on the FS 992 outboard bulk-head. It is important to note, however, that the indicated area is the same in which the 8 to 10-inch crack occurred during the second half of the second life test. As the damaged area was repaired with a bolted cover plate, an effective inspection was not possible.

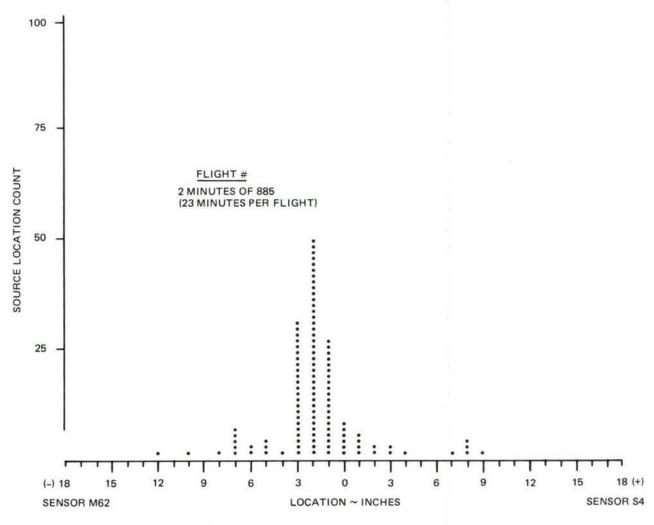
Fig. 33 FS 992 Outboard Bulkhead (Third Life)

Figure 31 shows the signal source locations ceased during flights 551 through 562. The multiple signals did not reappear until flight 884. Figure 32 shows the reappearance of the signal source locations between sensors M61 and S4. Another axis was monitored during flight 885 to pinpoint the location of the signal source locations being generated between locating sensors M6(1) and S4. The histogram of the signal source locations being generated between locating sensors M62 and S4 is shown in Fig. 33. The area of indicated source activity is the shaded area of Fig. 34.

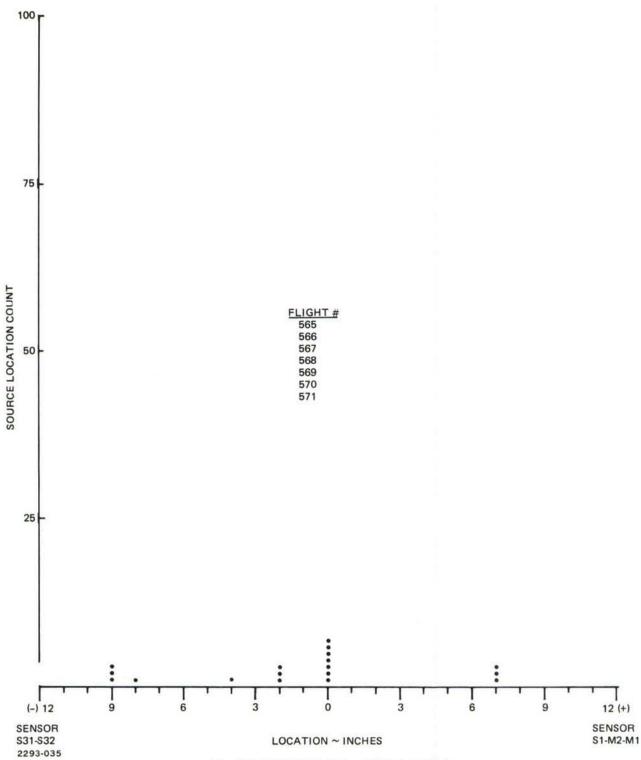
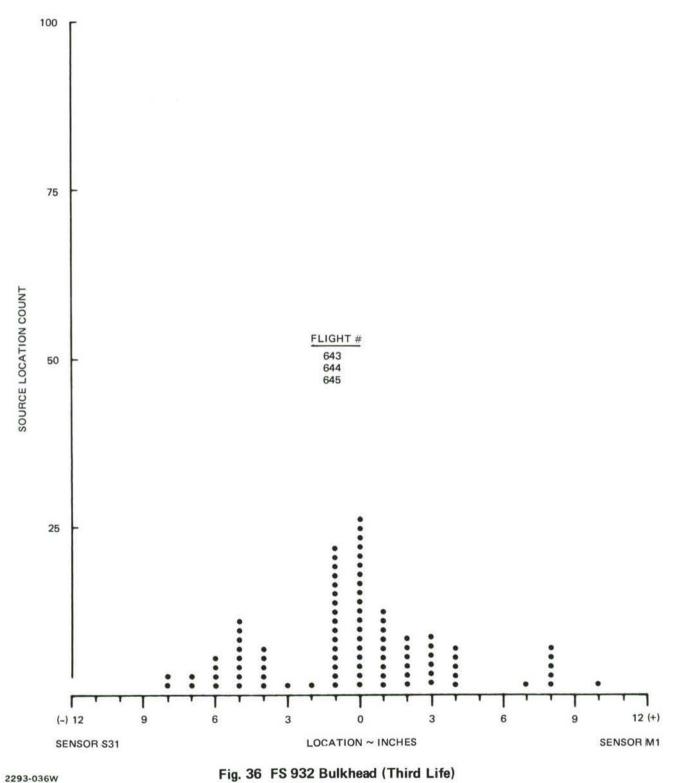
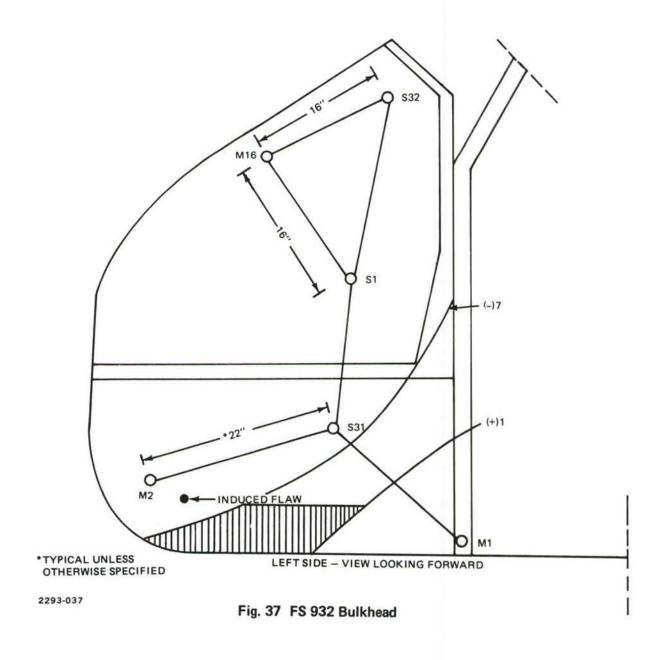
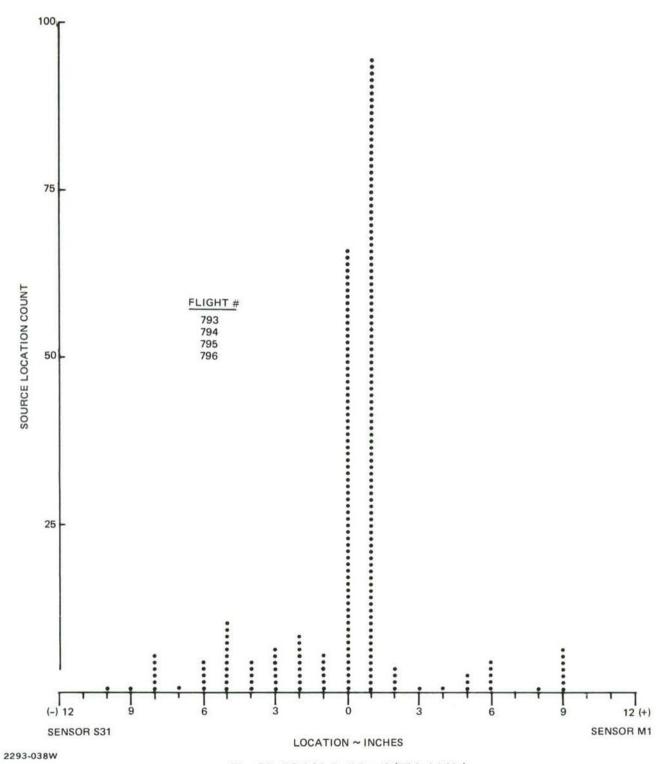
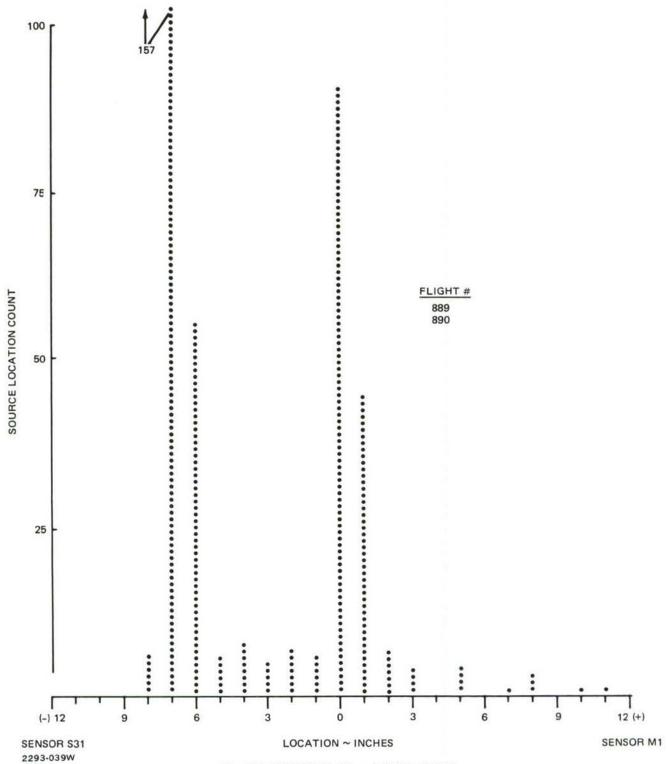
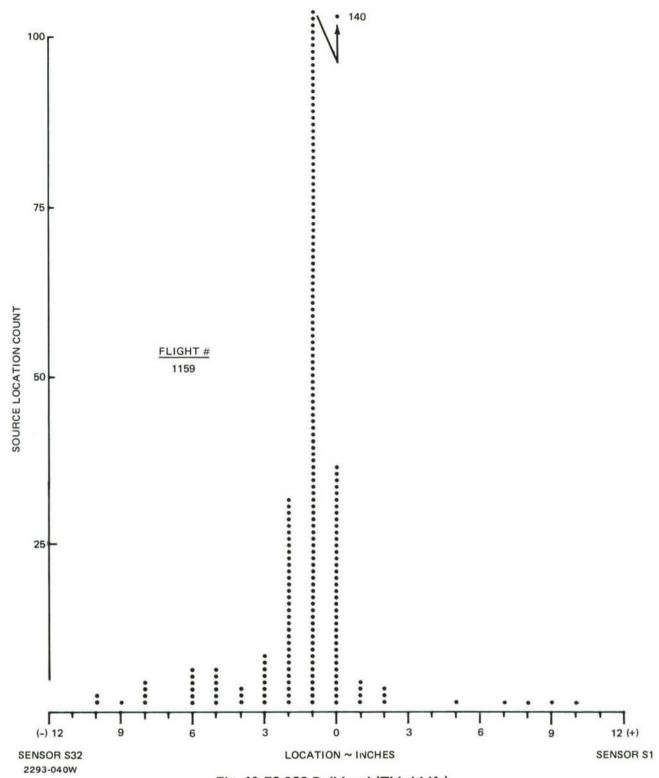
Fig. 35 FS 932 Bulkhead (Third Life)

Figures 35 through 39 illustrate the acoustic emission activity generated from the lower half of the FS 932 bulkhead during monitoring of the third fatigue life. The FS 932 bulkhead had very little acoustic emission activity until flight 643. Figure 35 shows that the activity on the FS 932 bulkhead during flights 565 through 571 is virtually non-existent. During

flights 643 through 645, there was an accumulation of signal source locations, as shown in Fig. 36.

An attempt was made to monitor sensors M2 and S31 to determine a location of the activity shown in Fig. 36, by monitoring a different axis. However, signal source locations could not be located by sensors M2 and S31 because of a high background noise level detected by sensor M2. It was determined that the cause of the high background noise level at sensor

M2 was an air leak, shown in the shaded area of Fig. 37. The remainder of the third life test was monitored without the use of sensor M2.

The multiple signal source locations that were generated increased in number as the test continued. Figure 38 shows the increase in signal source locations generated during flights 793 through 796. In Fig. 39 there are signal source locations in two areas between locating sensors S3₁ and M₁, during flights 889 and 890, indicating the possibility of more than one source of activity, as indicated in the shaded area of Fig. 37. No cracks could be found during the Quality Control inspection at the end of the third life. However, an inspection after flight 500 of the fourth fatigue life revealed four cracks up to 6 inches long emanating from four bolt holes in the shaded area of Fig. 37. The air leak previously detected originated from these cracks.

During flight 1159, activity was detected on the upper half of the FS 932 bulkhead, as shown in Fig. 40. Monitoring of this area was discontinued after flight 1164 until an additional locating sensor could be installed to verify the exact origin bf the signal source locations on an additional axis. (Sensor M16 was installed at the beginning of the fourth fatigue life.)

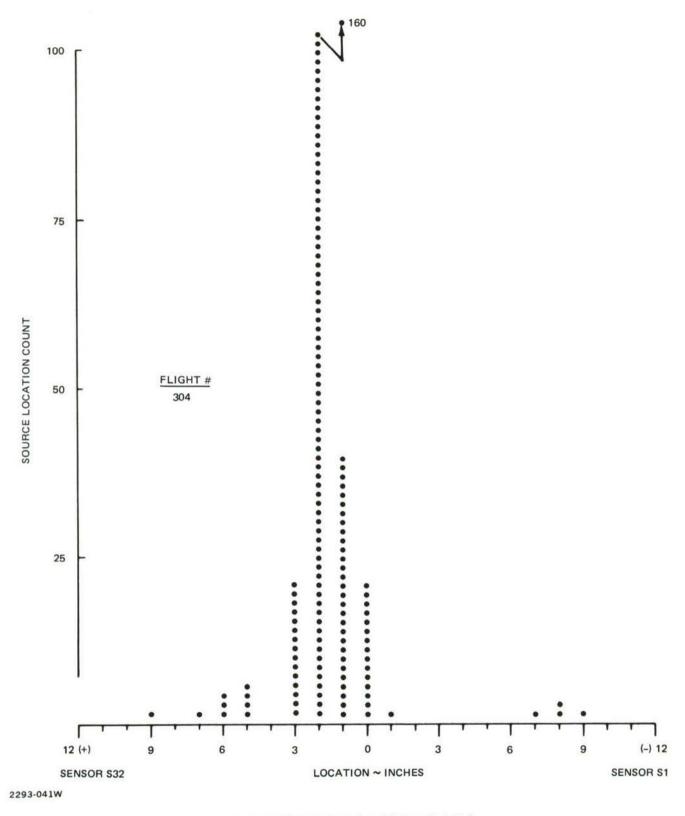
Fig. 41 FS 932 Bulkhead (Fourth Life)

There was significant activity on the upper half of the FS 932 bulkhead during the fourth fatigue life test. Figure 41 shows the presence of the same activity as detected by the signal source locations in Fig. 40 during third-lifetime monitoring.

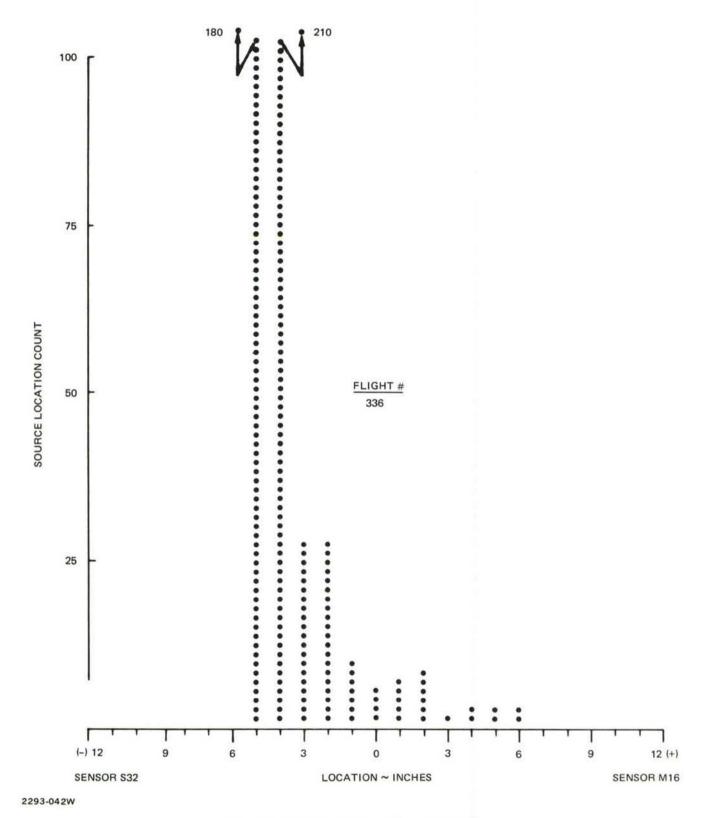
Fig. 42 FS 932 Bulkhead (Fourth Life)

The signal source locations were detected on two additional axes, as shown in Fig. 42 and 43. The signal source origin of the signals detected on the three axes is shown in the shaded area of Fig. 44. Figure 45 shows the area continued to be active during flights 798 and 799. The shaded area of Fig. 44 was inaccessible and could not be inspected with conventional methods. Verification of the source of the activity detected cannot be determined until the structure is dismantled and the area made accessible for inspection. Locating sensors 17 and 18 were installed on the lower wing pivot which had an induced flaw that was propagating before the area was monitored, as shown in Fig. 46. Signal sources were detected at the locations shown in Fig. 47 and 48 during flights 705 to 708 and 1004 to 1006, which correspond to the flaw location. Acoustic emission monitoring was able to detect crack propagation signals from the time of initial setup on the wing pivot until the end of the fourth life test.

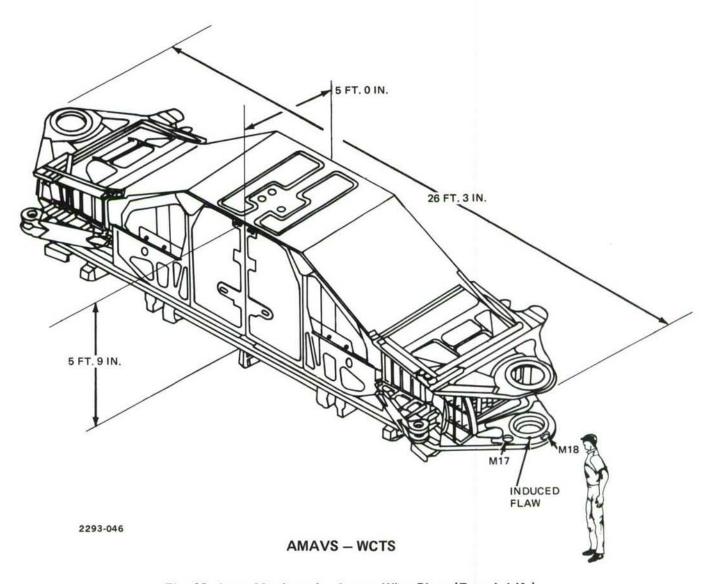
Fig. 46 Areas Monitored — Lower Wing Pivot (Fourth Life)

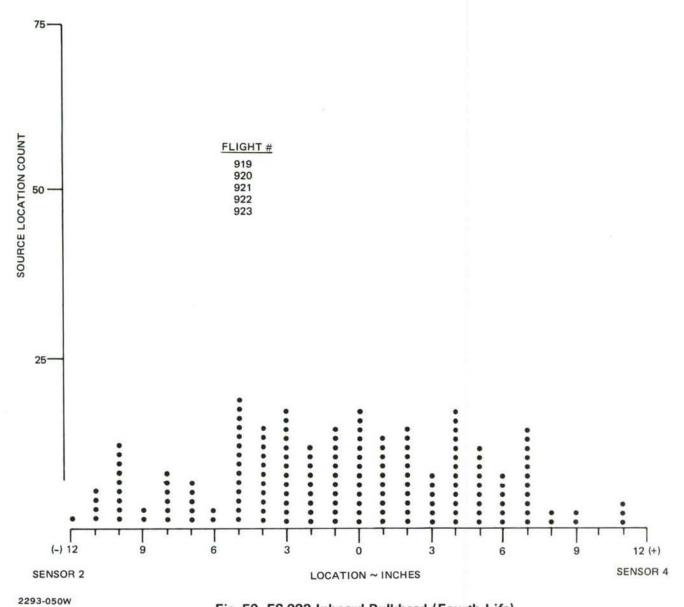
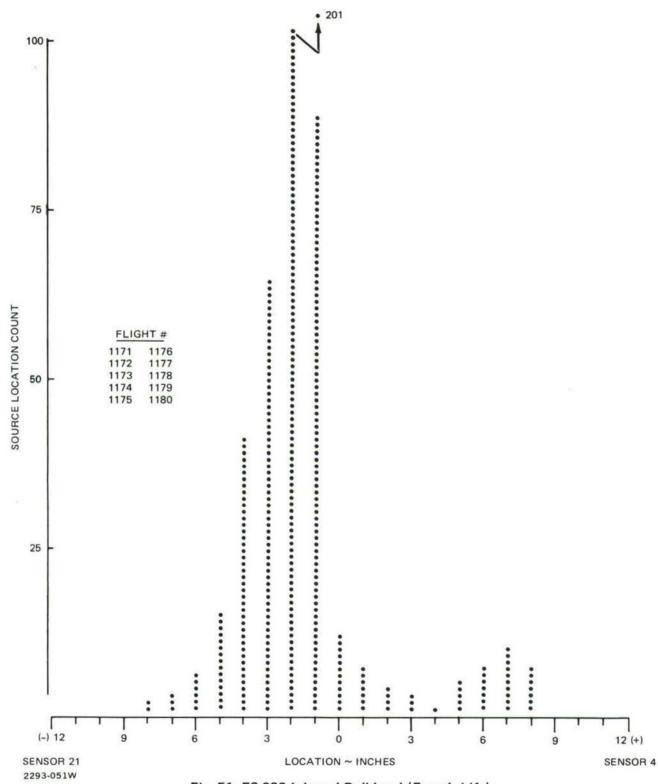
Fig. 50 FS 992 Inboard Bulkhead (Fourth Life)

The FS 992 inboard bulkhead showed no signs of any acoustic emission activity during the entire fatigue test until flight 919 of the fourth fatigue life. Figure 49 shows the FS 992 inboard bulkhead with very little activity from flights 424 through 431. An increase in activity on the bulkhead is shown in Fig. 50 between locating sensors 2 and 4. The signal source locations, however, did not accumulate at any one location.

Locating sensors 4 and 20, 3 and 20, 3 and 19, 1 and 19, and 1 and 2 were monitored, but these axes showed no sign of any activity. Based on this result, locating sensor 21 was installed to monitor the lower left area with an additional axis. Figure 51 shows the signal source locations detected by locating sensor axis 4 and 21. This location is shown in the shaded area of Fig. 52. As the fatigue test was near completion, there were not enough cycles left to determine the cause of the signal source location between sensors 2 and 4 or pinpoint the signal source location in the lower left hand corner after detection by sensors 4 and 21. A visual inspection of the area by AE personnel revealed no signs of cracking or damage. However, a thorough inspection after disassembly of all the surfaces in the area is required to determine the existence of an AE signal source.

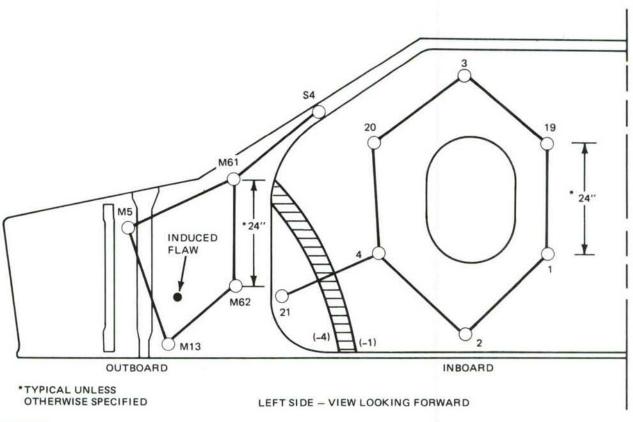
2293-052

Fig. 52 FS 992 Bulkhead

The areas where activity was detected with AE monitoring which are inaccessible for inspection should be examined when the AMAVS is dismantled. These areas are the FS 992 Outboard Bulkhead (Fig. 34), the FS 932 Bulkhead (Fig. 44), and the FS 992 Inboard Bulkhead (Fig. 52).

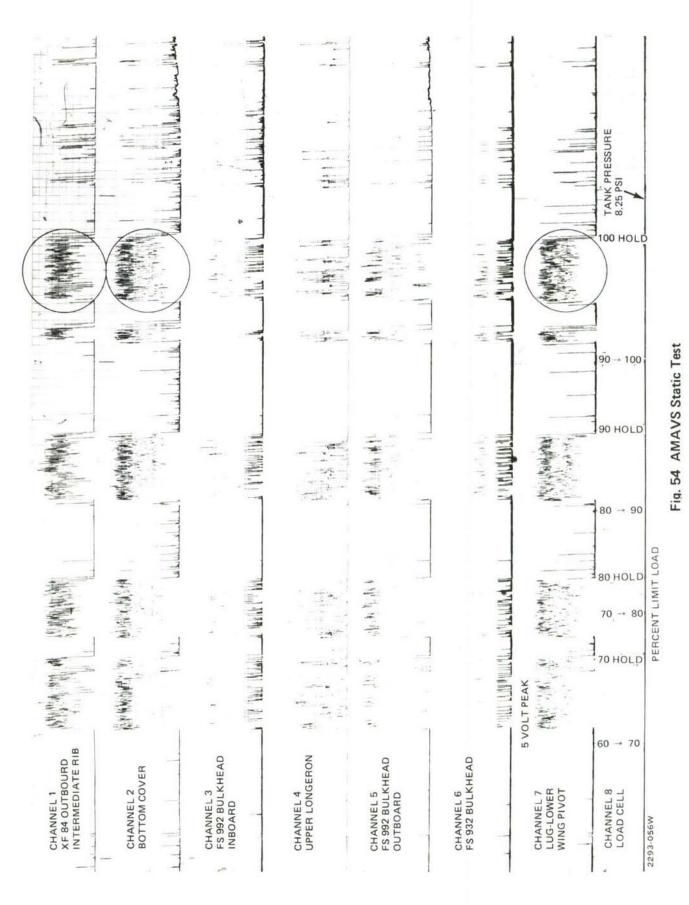
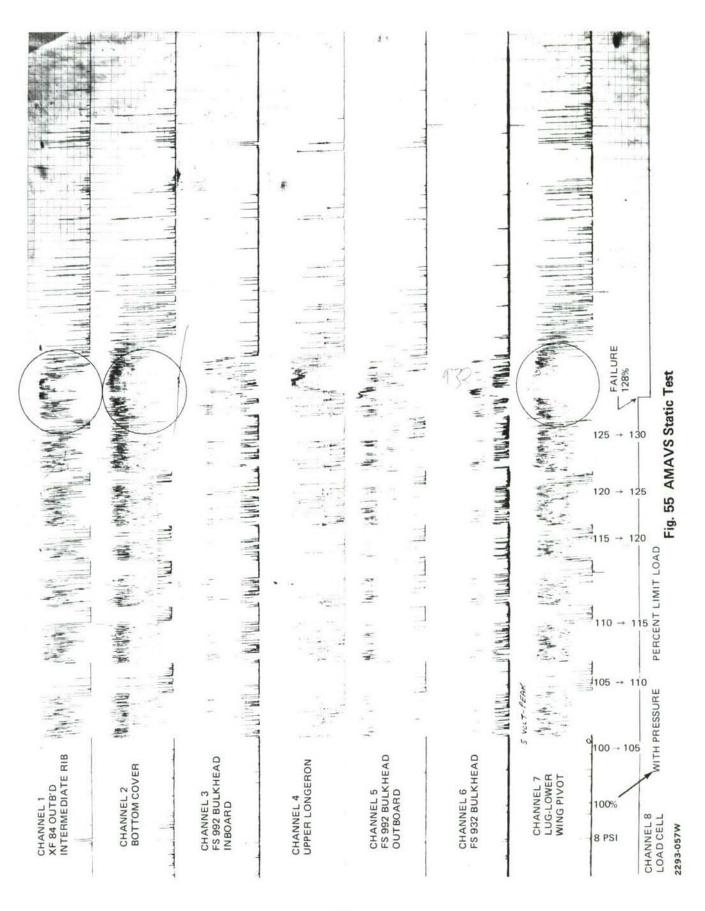
Figures 54 and 55 show the strip chart recordings of the detected activity during the aft sweep static loading increments. The maximum peak output of the amplifiers was 5 volts and is shown as the full voltage scale for each recording channel. A high degree of activity is denoted by the recording pen remaining at the maximum level as compared to pen excursions between zero and 5 volts. With reference to Fig. 54, it can be seen that the Lower/ Left Wing Pivot (Lug), Bottom Cover, and XF84 Outboard Intermediate Rib (circled areas) have a higher degree of activity than any of the other areas during the 100% loading. During the structural failure which occurred at 128% of limit load, as may be seen in Fig. 55, high activity was detected on the Lower Wing Pivot (Lug) and the Bottom Cover (circled areas). The failed structural member (lower forward outboard longeron), was located between these two areas. A high degree of activity was also detected on the XF84 Outboard Intermediate Rib which was adjacent to the Bottom Cover area.
